Building design guide

The Orangery

Essential repairs to a Grade II* listed building on the Heritage at Risk Register, September 2013

Tyntesfield Estate, North Somerset

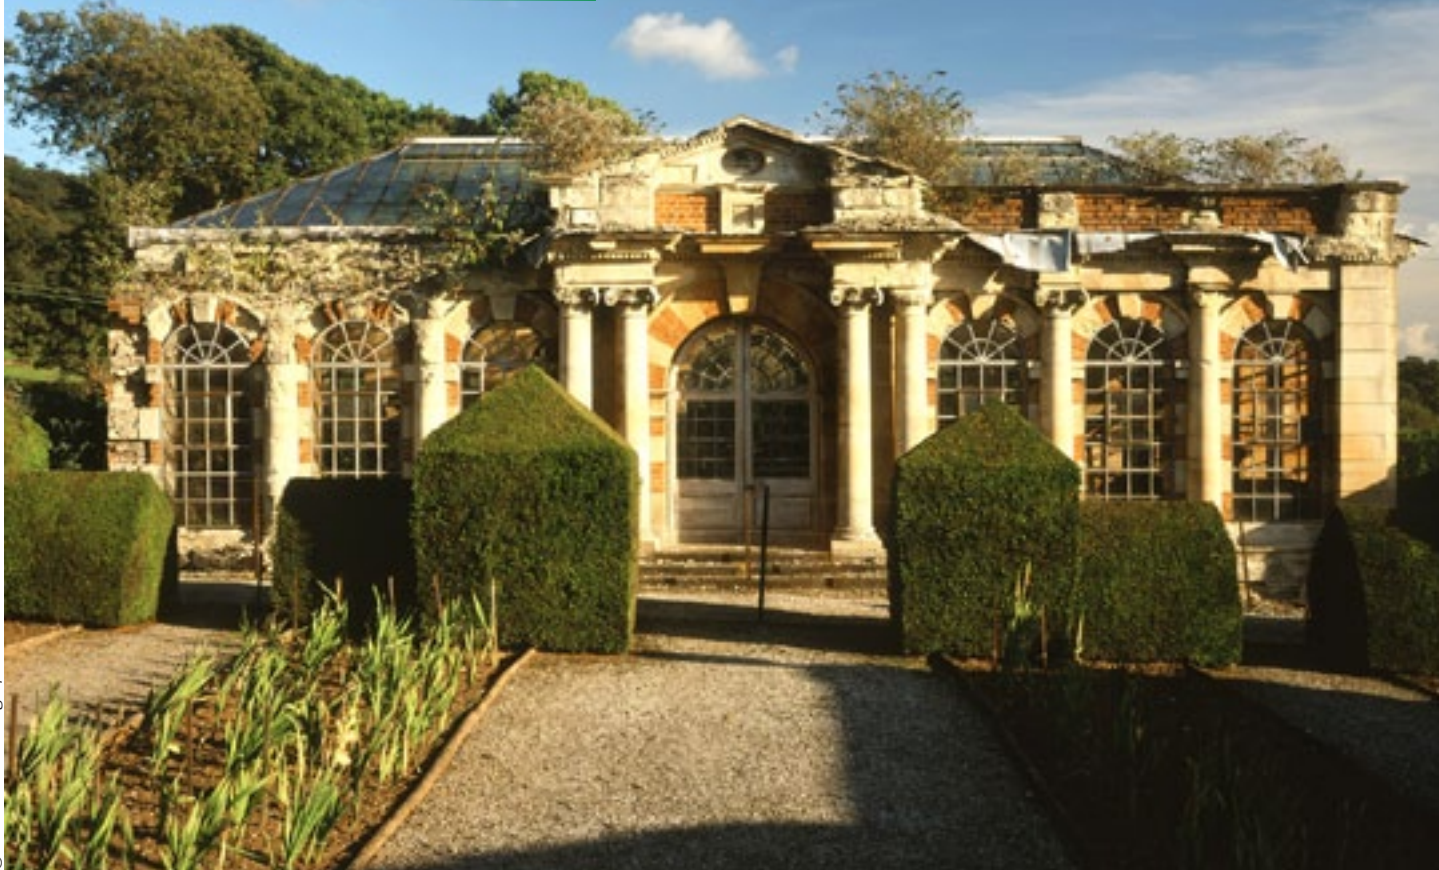
Above **The Orangery** was listed on the **Heritage at Risk** register

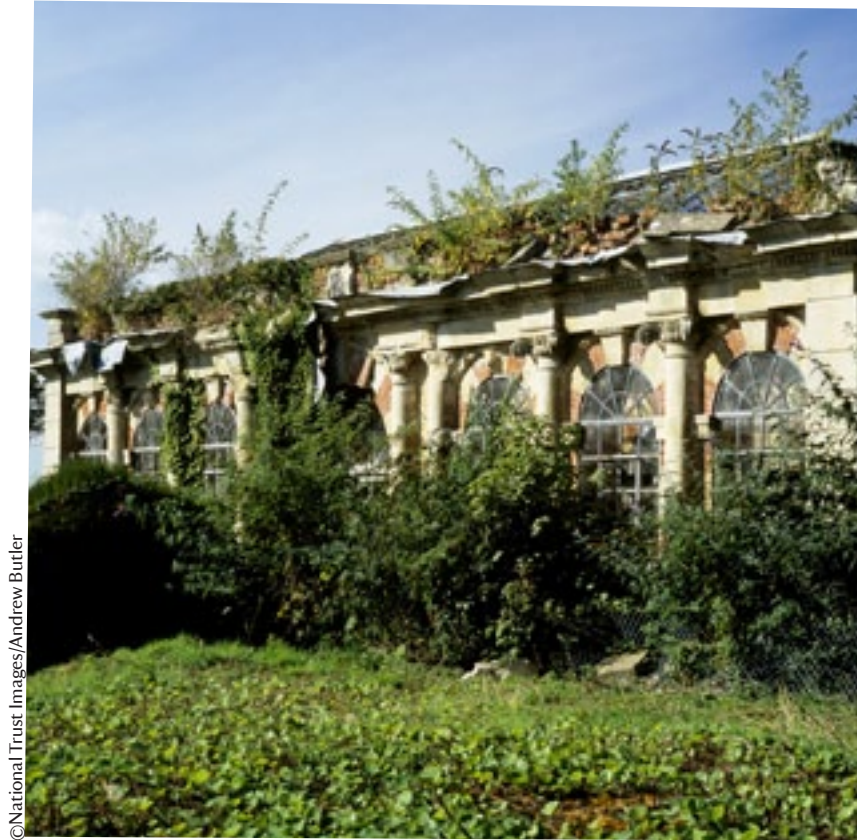
Above The rear of the Orangery before the project, overgrown with plants and in need of extensive repair

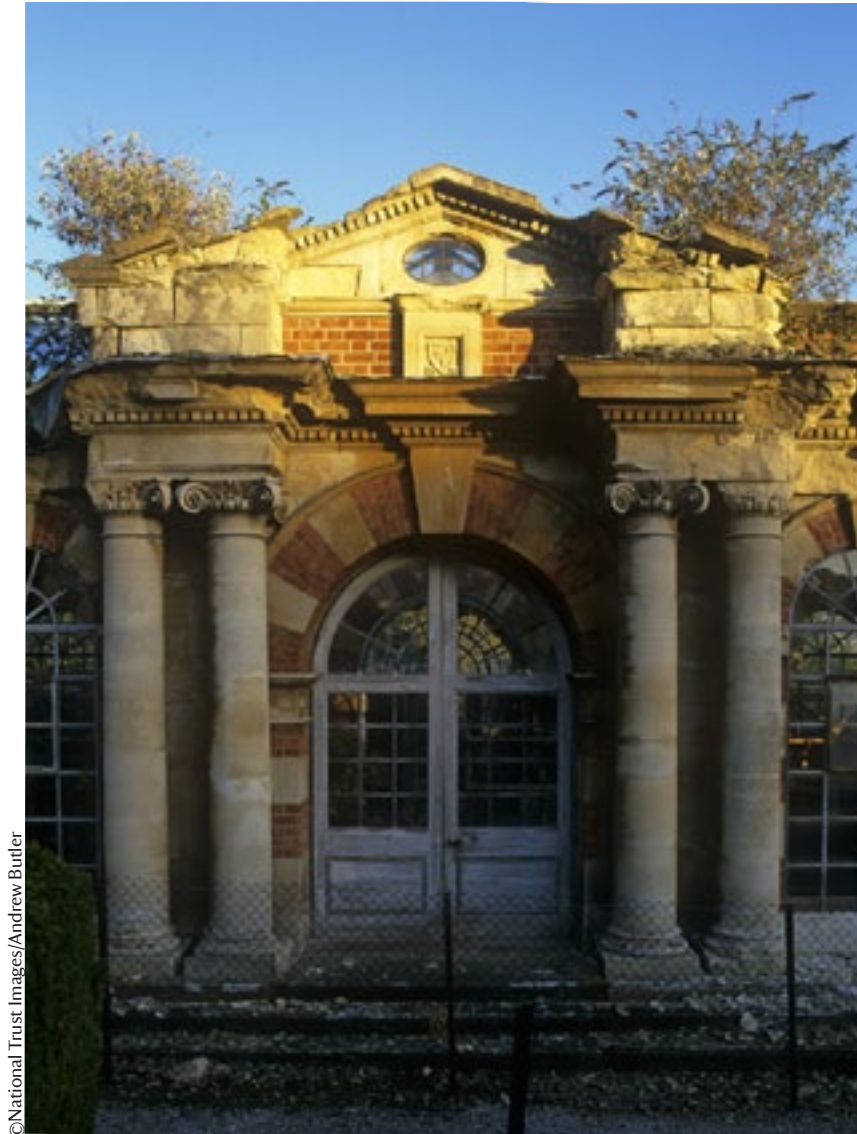
Above Detail of the Orangery door showing the decaying stonework

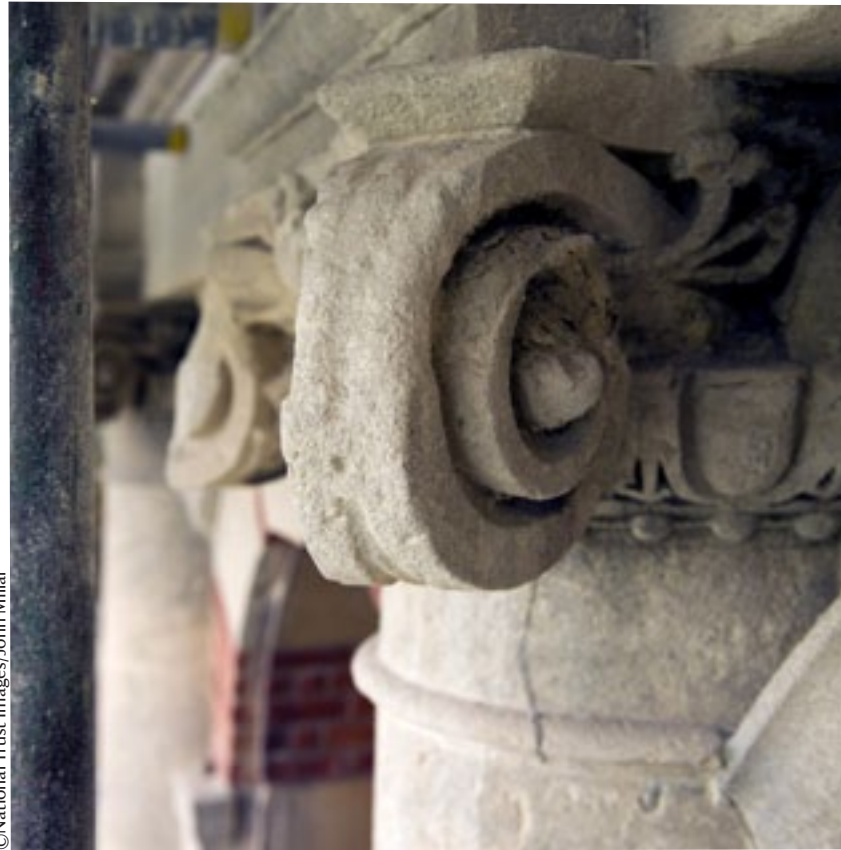
Above Capitals in need of conservation work

■ **Architectural detailing** All damaged or missing elements with a structural or weathering function were fully repaired or replaced. Where extensive loss of architectural detailing such as columns, capitals, decorative mouldings were considered of major significance for the building's architectural quality they were made good. Where insufficient historic material was left to determine the decorative detailing, the stone masons were given the freedom to design based on the patterns used elsewhere on the building eg. capitals.

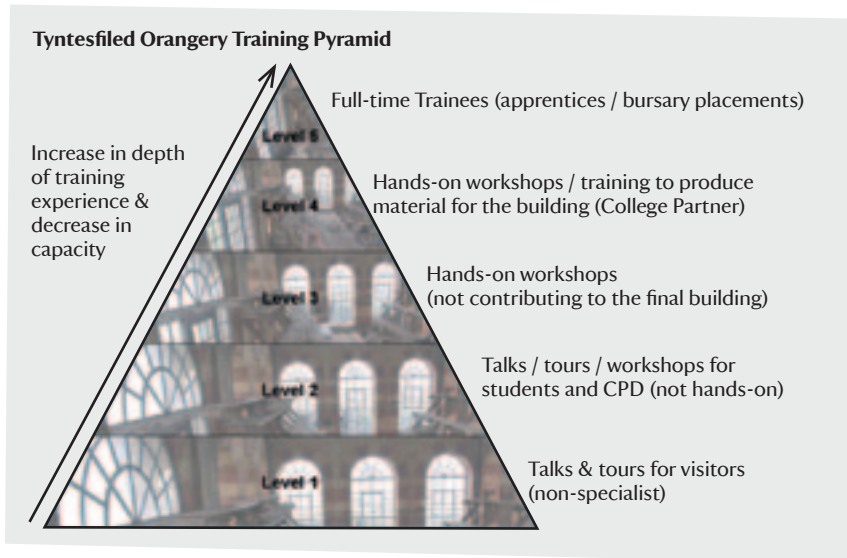
Above left **Skills pyramid diagram**

■ **Engagement** The scope of engagement and interpretation opportunities were analysed and a skills pyramid drawn up to represent the different levels of training opportunities available to the project.

These were defined at five levels:
(See diagram above left)

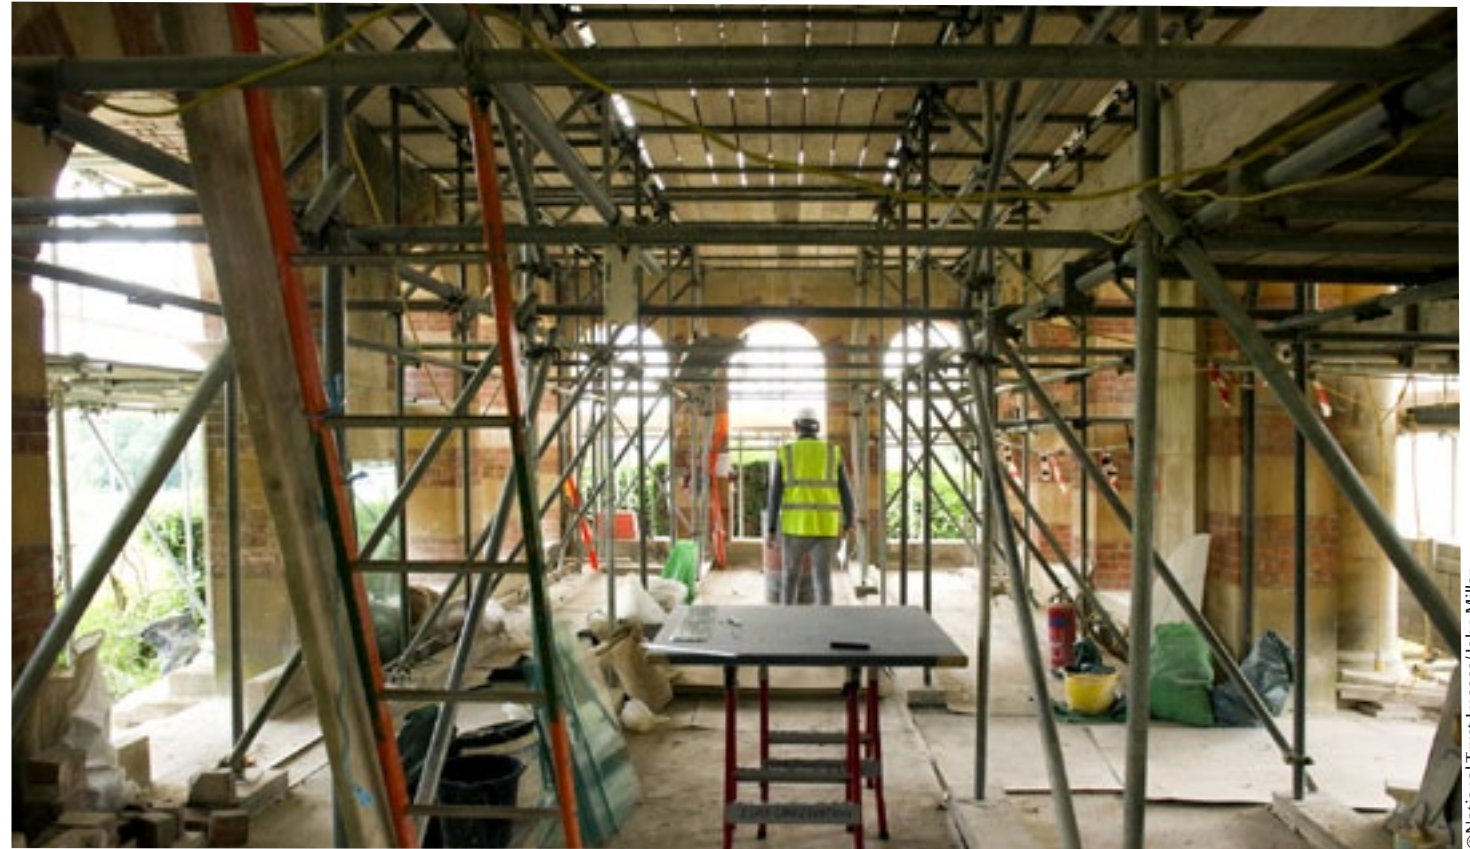
Above Works in progress

- Re-design of the rainwater goods, including improved falls to the lead gutters and deeper catch pits to improve the ability of the roof to cast off water which was thought to be partly responsible for the extent of the decay.

- Replacement of the existing concrete coping stones with Bath stone as they were considered to be largely responsible for the deterioration of the walls given their inability to sufficiently shed water. The new coping stones were designed to match detailing, including drip and overhang, of the original 19th century coping found amongst the debris in and around the Orangery.

- Introduction of a new polythene DPC at the base of parapet to prevent water ingress.

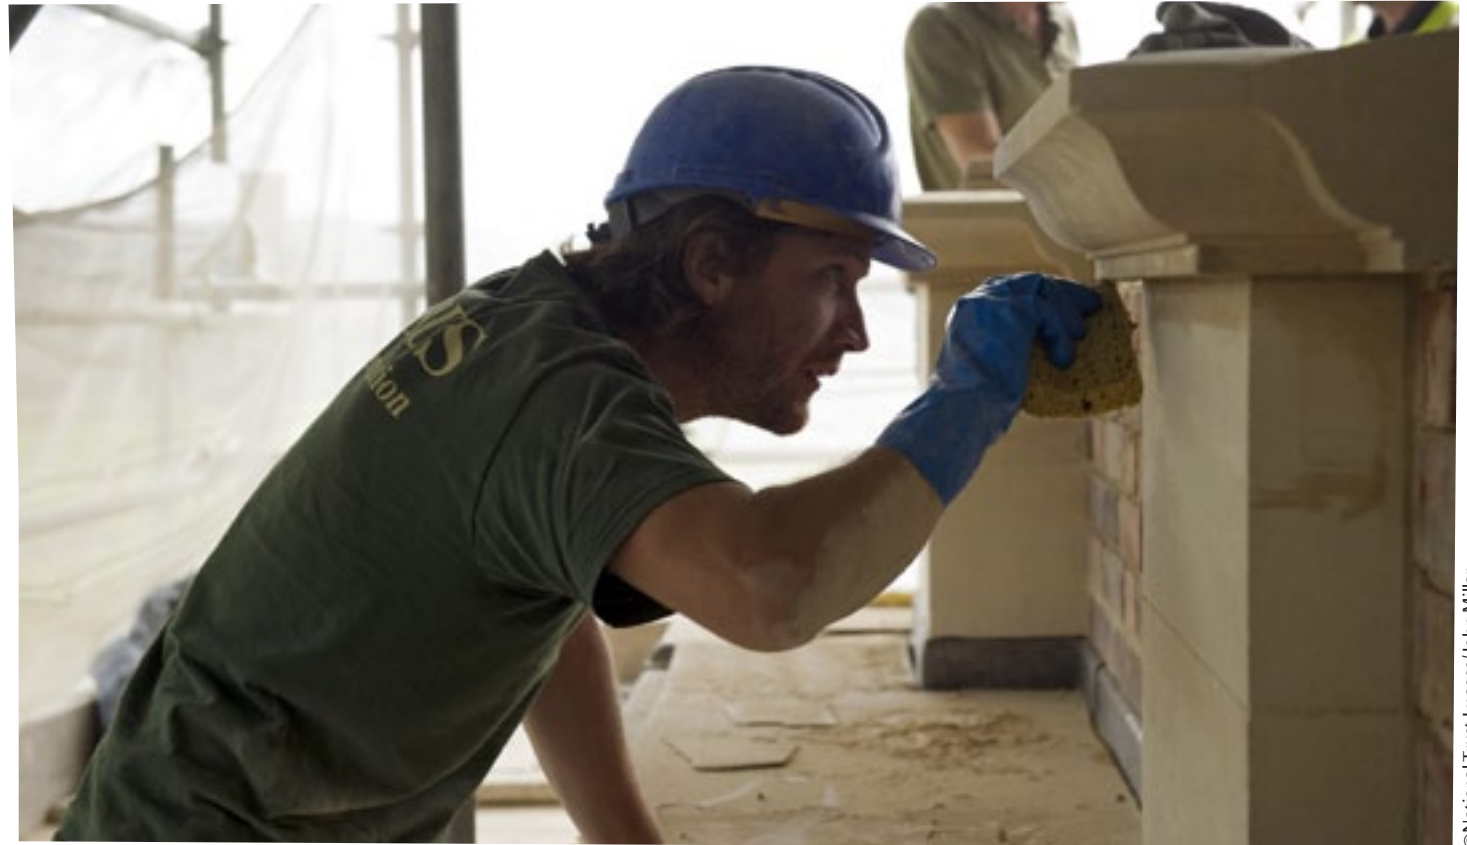
Above Stonemason undertaking repair works

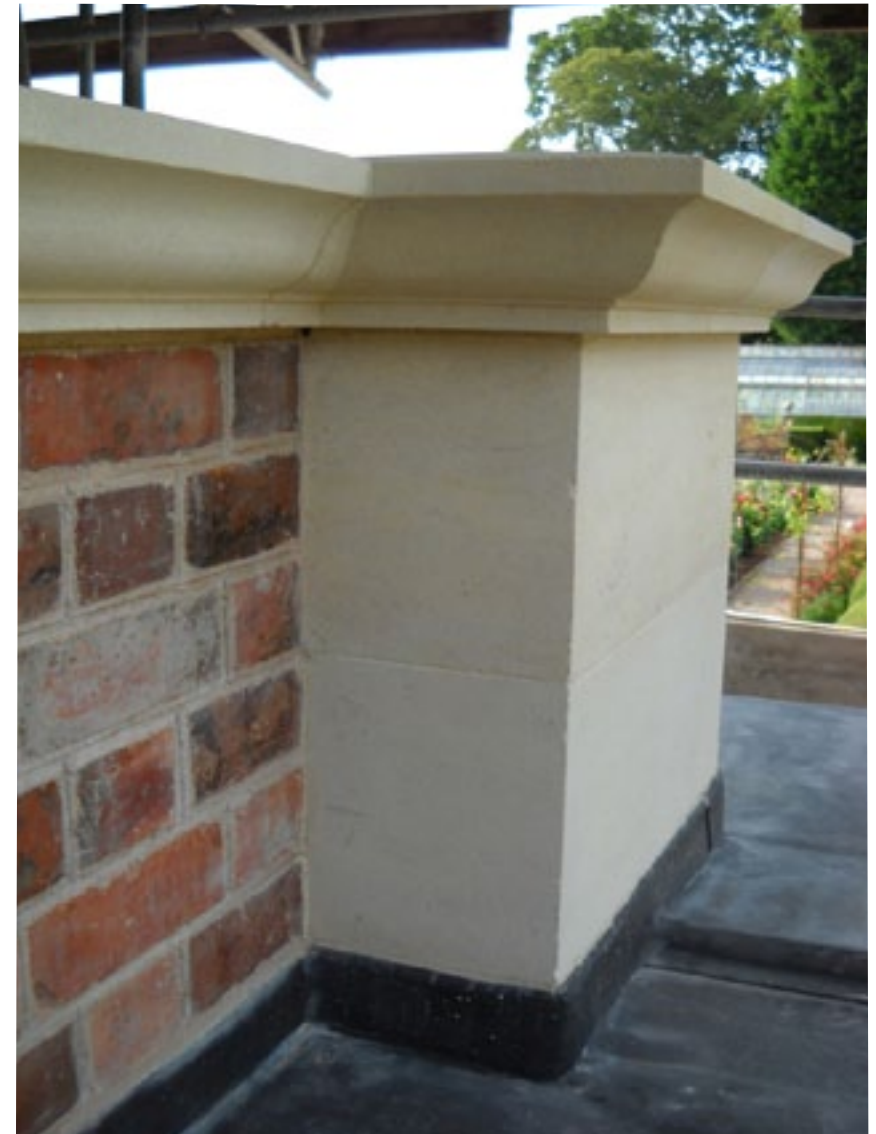
**Above Completed
parapet September
2011**

It has a metal framed glazed roof with opening lights, a brick and Bath stone parapet with concrete coping stones and leaded gutters that feed into rainwater tanks. The concrete copings were replaced with new Bath stone copings during the project.

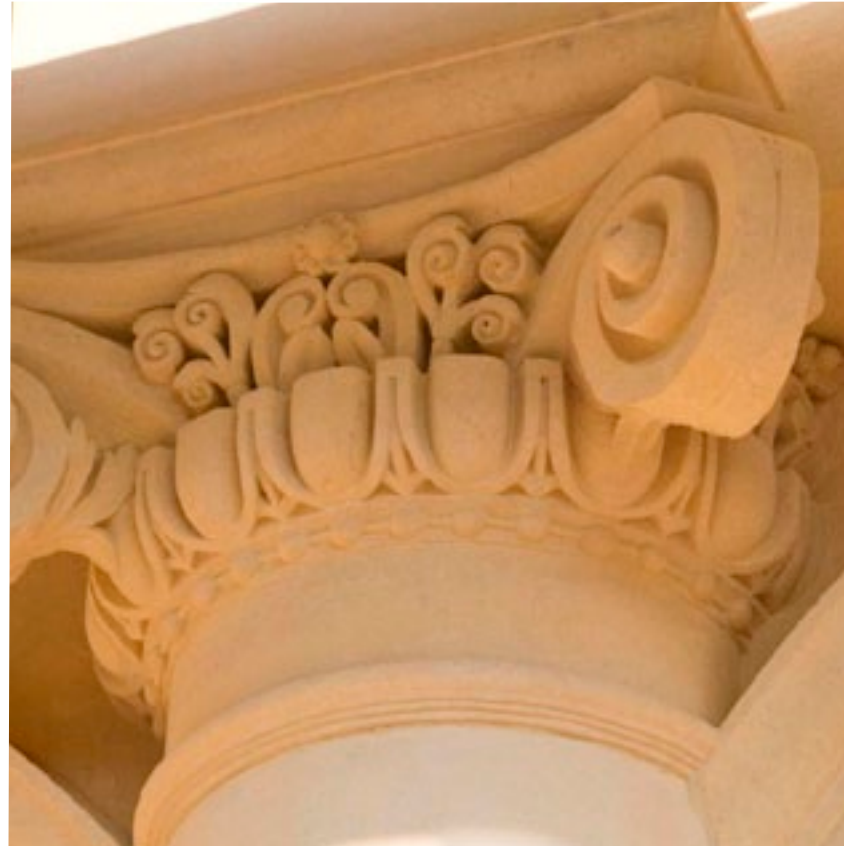
Above Completed capital September 2011

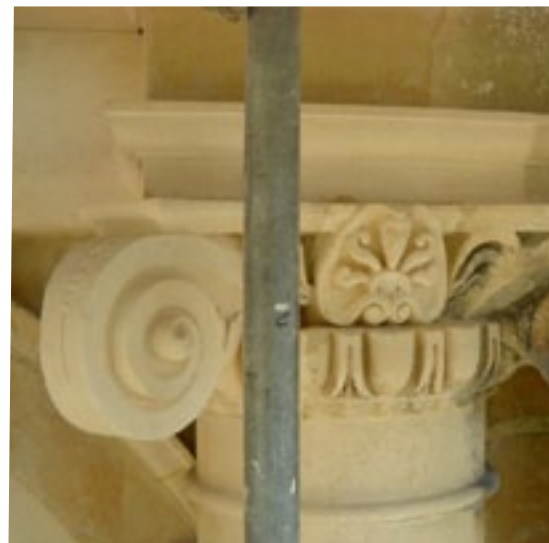
Left Completed capital September 2011

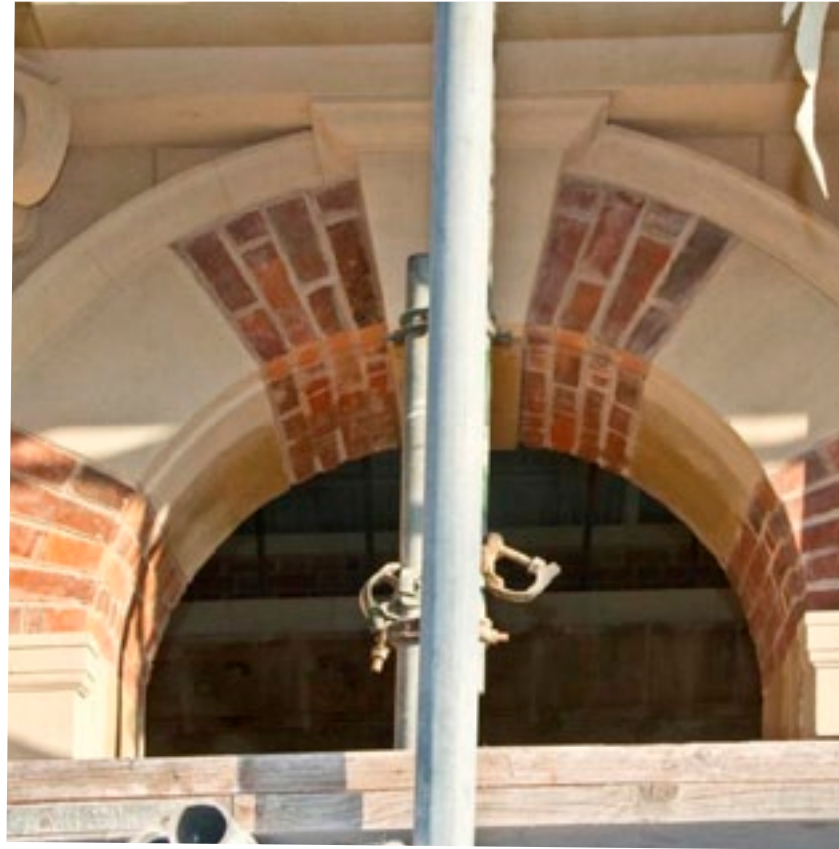
Above Completed voussoirs September 2011

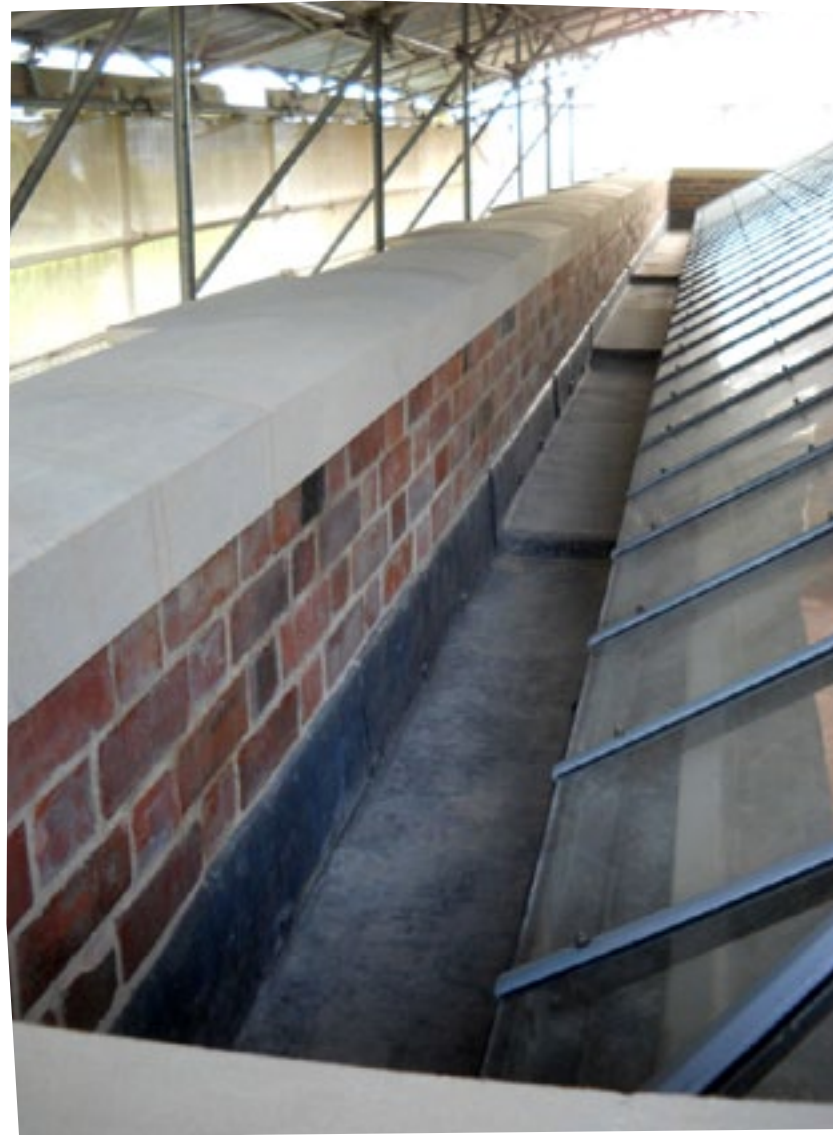
Above **Completed gutter September 2011**
