ENGLISH HERITAGE  
PRACTICAL BUILDING CONSERVATION

# CONCRETE

*This chapter covers the principal methods which can be used for the repair and preservation of concrete, and provides guidance as to when particular treatments might be appropriate.*

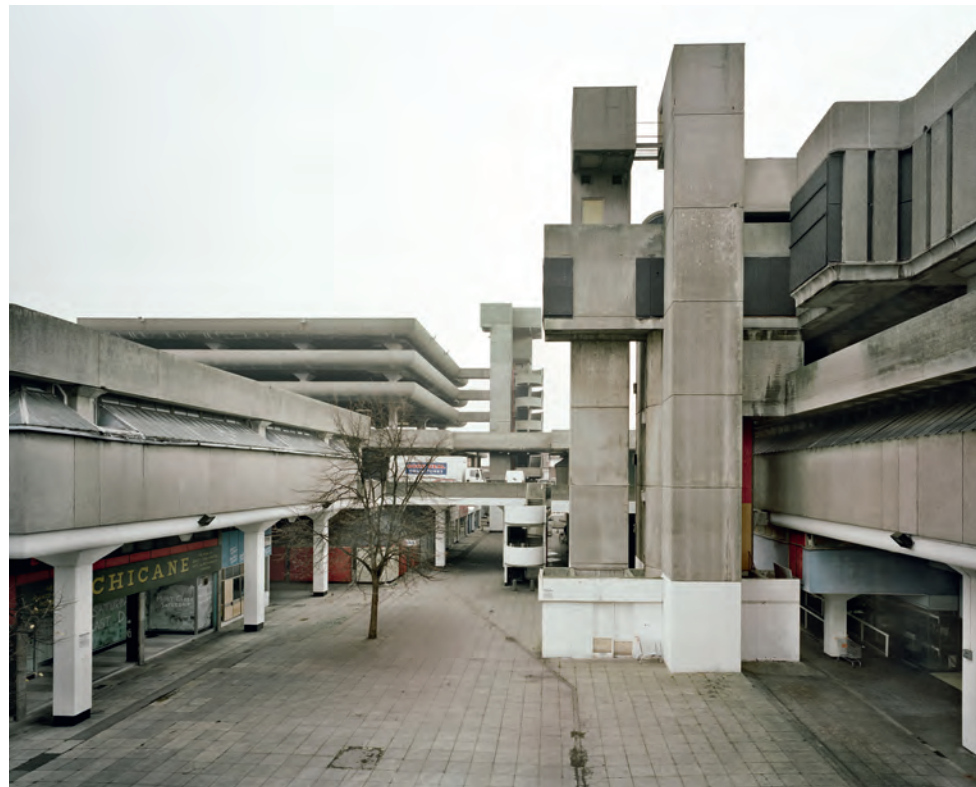
Opened in 1966, the concrete at the Tricorn Centre, Portsmouth, deteriorated quite rapidly partly due to design issues, but also due to the wet coastal climate. Attempts to get it listed as a fine example of Brutalist architecture were turned down and it was demolished in 2004, despite an active campaign for its preservation.

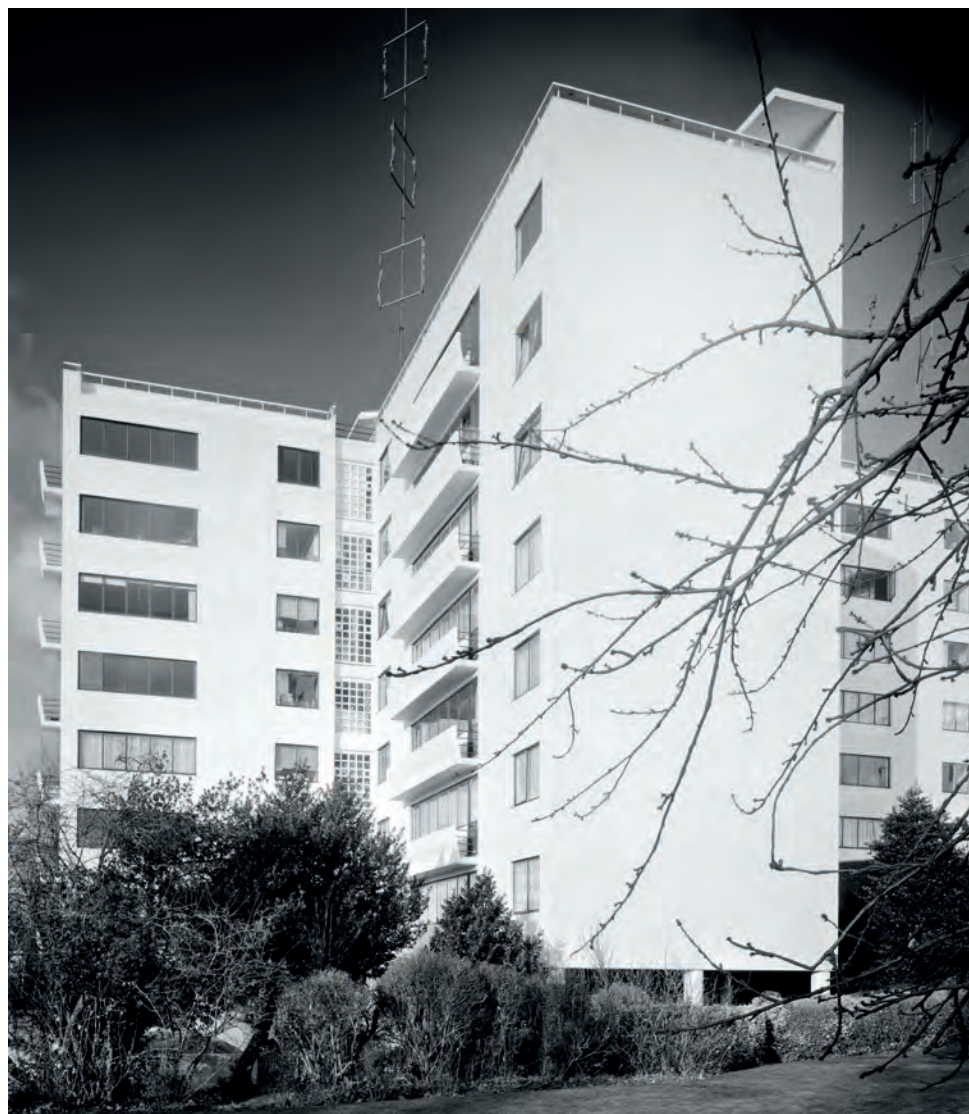
Highpoint I, Highgate, London, 1933–35. The flats were originally commissioned to house staff from the Gestetner company. Corbusier described them as *“an achievement of the first rank”*.

One influential figure from this era was Berthold Lubetkin. He and Tecton built Highpoint I (comprising 56 flats) during the years 1933–35. This construction utilised a method developed by engineer Ove Arup, in which floor slabs spanned external load-bearing walls and spine beams rested on a central row of columns, thus limiting the free plan. By 1936, however, when Lubetkin and Arup began Highpoint II, this problem was resolved. They used a different construction, with double-height living rooms at the centre of the luxury flats. By making the internal cross walls and floors structural – using a box frame – the elevations were free to be light and highly glazed; this technique was to transform post-war building construction.

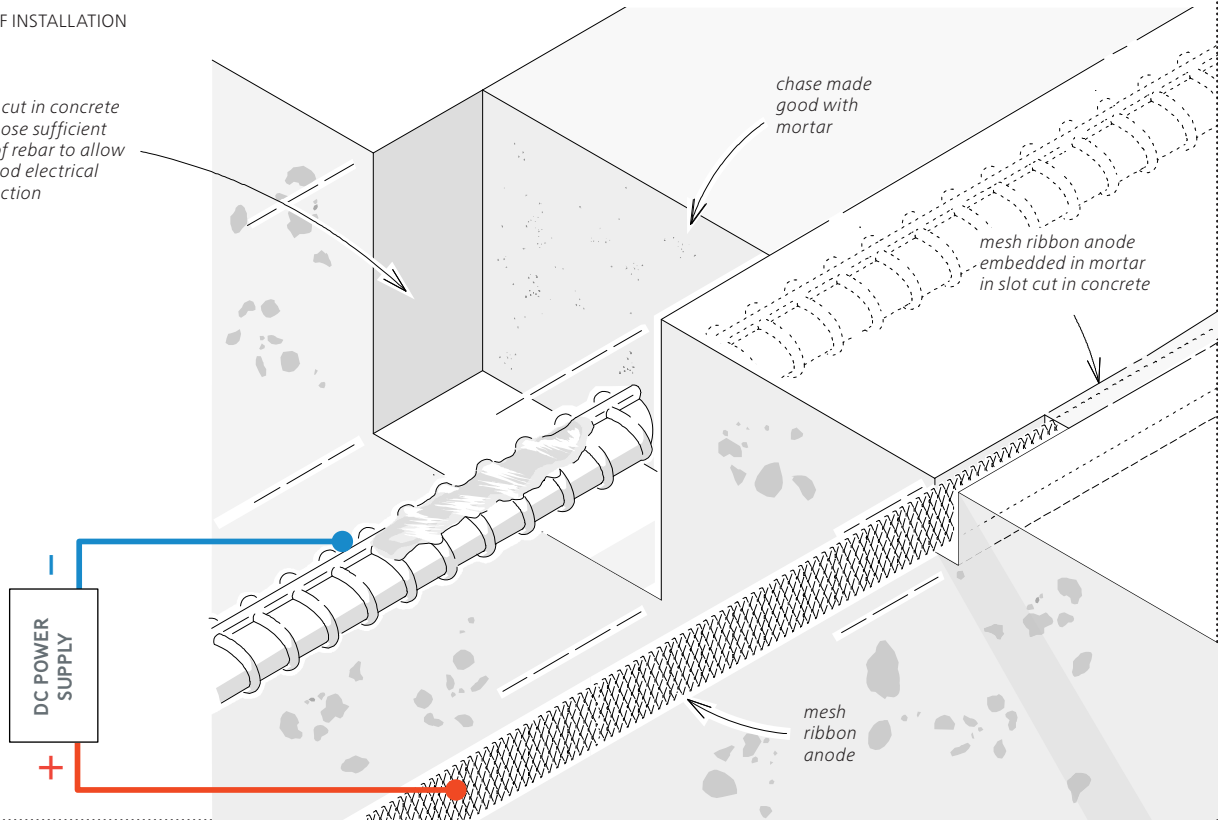
**EXAMPLE OF INSTALLATION**

chase cut in concrete to expose sufficient area of rebar to allow for good electrical connection

mesh ribbon anode embedded in mortar in slot cut in concrete

mesh ribbon anode

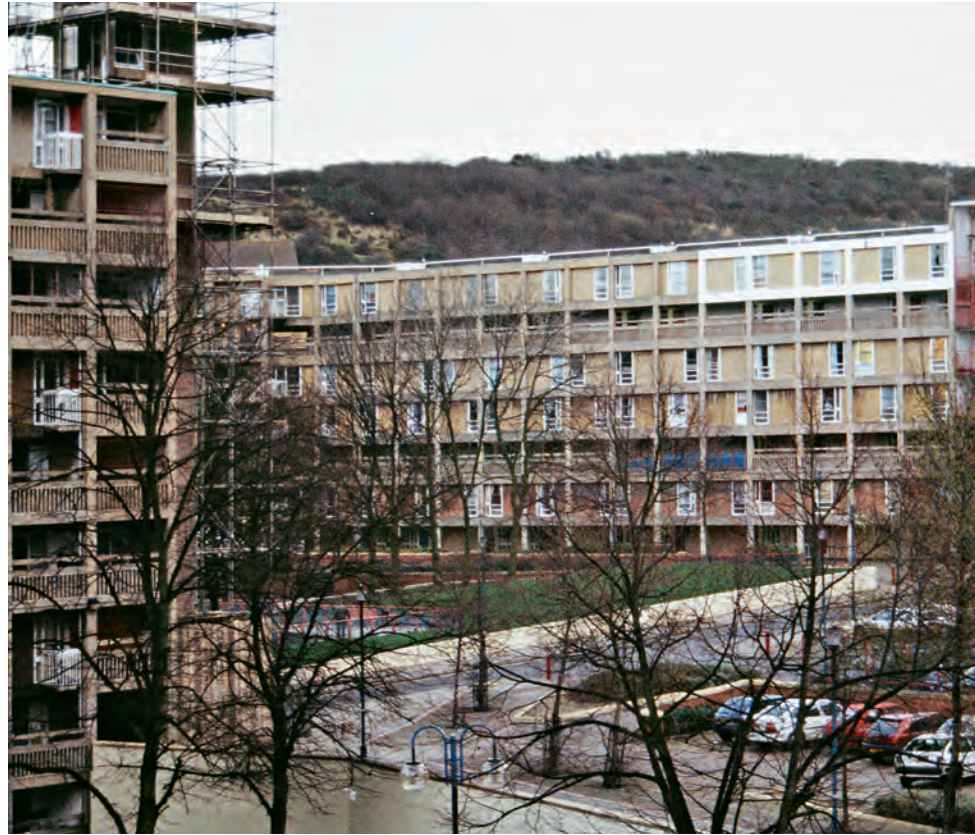
A number of remedial treatments were trialled at Park Hill, Sheffield, to try and overcome corrosion problems. The intention was to develop a range of repairs which would maintain as far as possible the appearance of the buildings; these included hydrophobic treatments, like-for-like patch repairs, anti-carbonation coatings and selective replacement. The anti-carbonation coatings were matched to the colour of the cleaned concrete, but still have a significant aesthetic effect as shown in the top of the image. There were powerful local demands for the demolition of the whole estate because of increasing social problems and its deteriorating appearance. A drastic solution was needed and listed building consent was eventually given for a scheme which kept the structural frame and essential form of the buildings, but replaced the walls, windows and interiors.

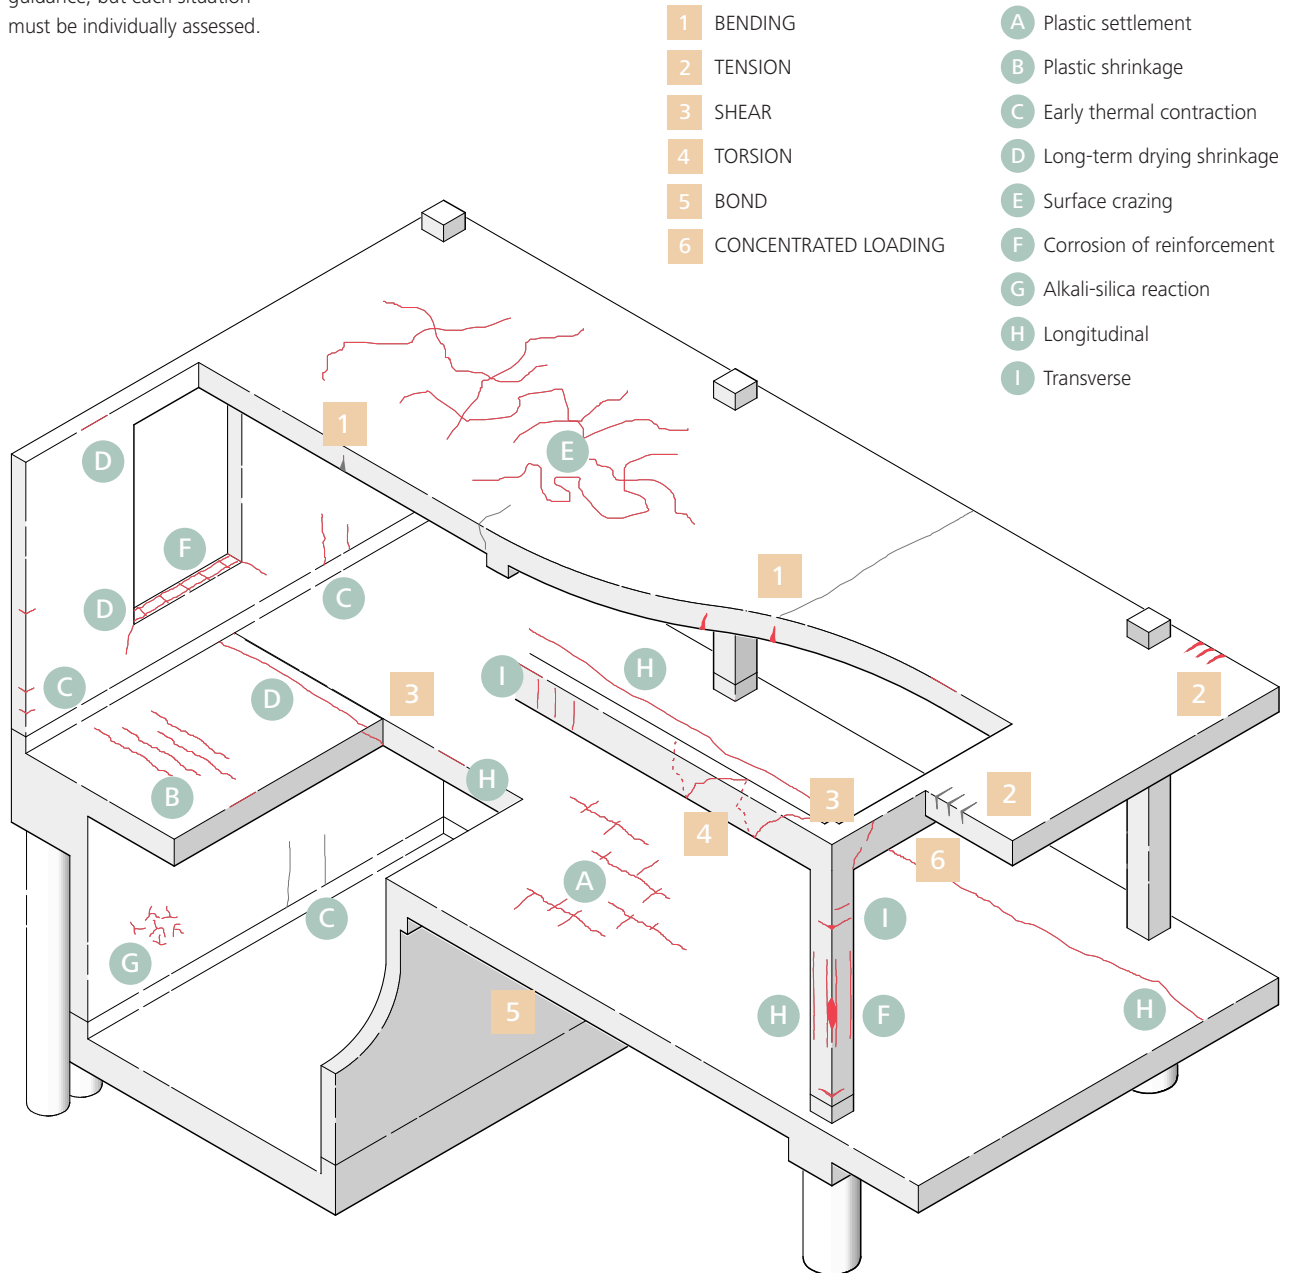
### TYPICAL LOCATION & APPEARANCE OF STRUCTURAL & NON-STRUCTURAL CRACKING

This diagram provides general guidance, but each situation must be individually assessed.

| COMMON TYPES OF CRACKS IN CONCRETE | | |
| NAME | DESCRIPTION | POSSIBLE CAUSES |
| LONGITUDINAL CRACKS | Cracks formed after the concrete has hardened, aligned parallel to the reinforcing bars | Corrosion of steel reinforcement<br>Shrinkage of slabs formed with high cement content<br>AAR in columns and beams |
| TRANSVERSE CRACKS | Fine flexural transverse cracks, most common in columns and beams; follows the line of the secondary reinforcement<br><br>Generally precedes longitudinal cracking | Corrosion of steel reinforcement<br>Shrinkage<br>Thermally-induced movement |
| SHEAR CRACKS | Cracks formed after the concrete has hardened: unusual | Movement or loading of the structure<br>Demands closer structural investigation |
| PLASTIC SHRINKAGE CRACKS | Appear on the surface of fresh concrete soon after it is placed<br><br>Often parallel to each other and relatively shallow | Excessive evaporation of water from the setting concrete |
| PLASTIC SETTLEMENT CRACKS | Formed within the first few hours after pouring<br><br>Usually regularly spaced and following the line of the uppermost reinforcement, giving a series of parallel cracks<br><br>May also be shorter cracks at right angles over the bars running in the opposite direction | Settlement of fresh concrete has been restrained, causing differential settlement of the aggregate and cementitious mix<br><br>As water moves upward through the mixture, the denser constituents move downward; this downward movement may be obstructed by the top layer of reinforcement or by the shuttering |
| SURFACE CRAZING | Fine random cracks or fissures on the surface of concrete mortar; rarely more than 3 mm deep | Usually due to poor or inadequate curing<br><br>The mix being too wet or excessive floating allows for excessive concentration of cement and fine aggregate at the surface |

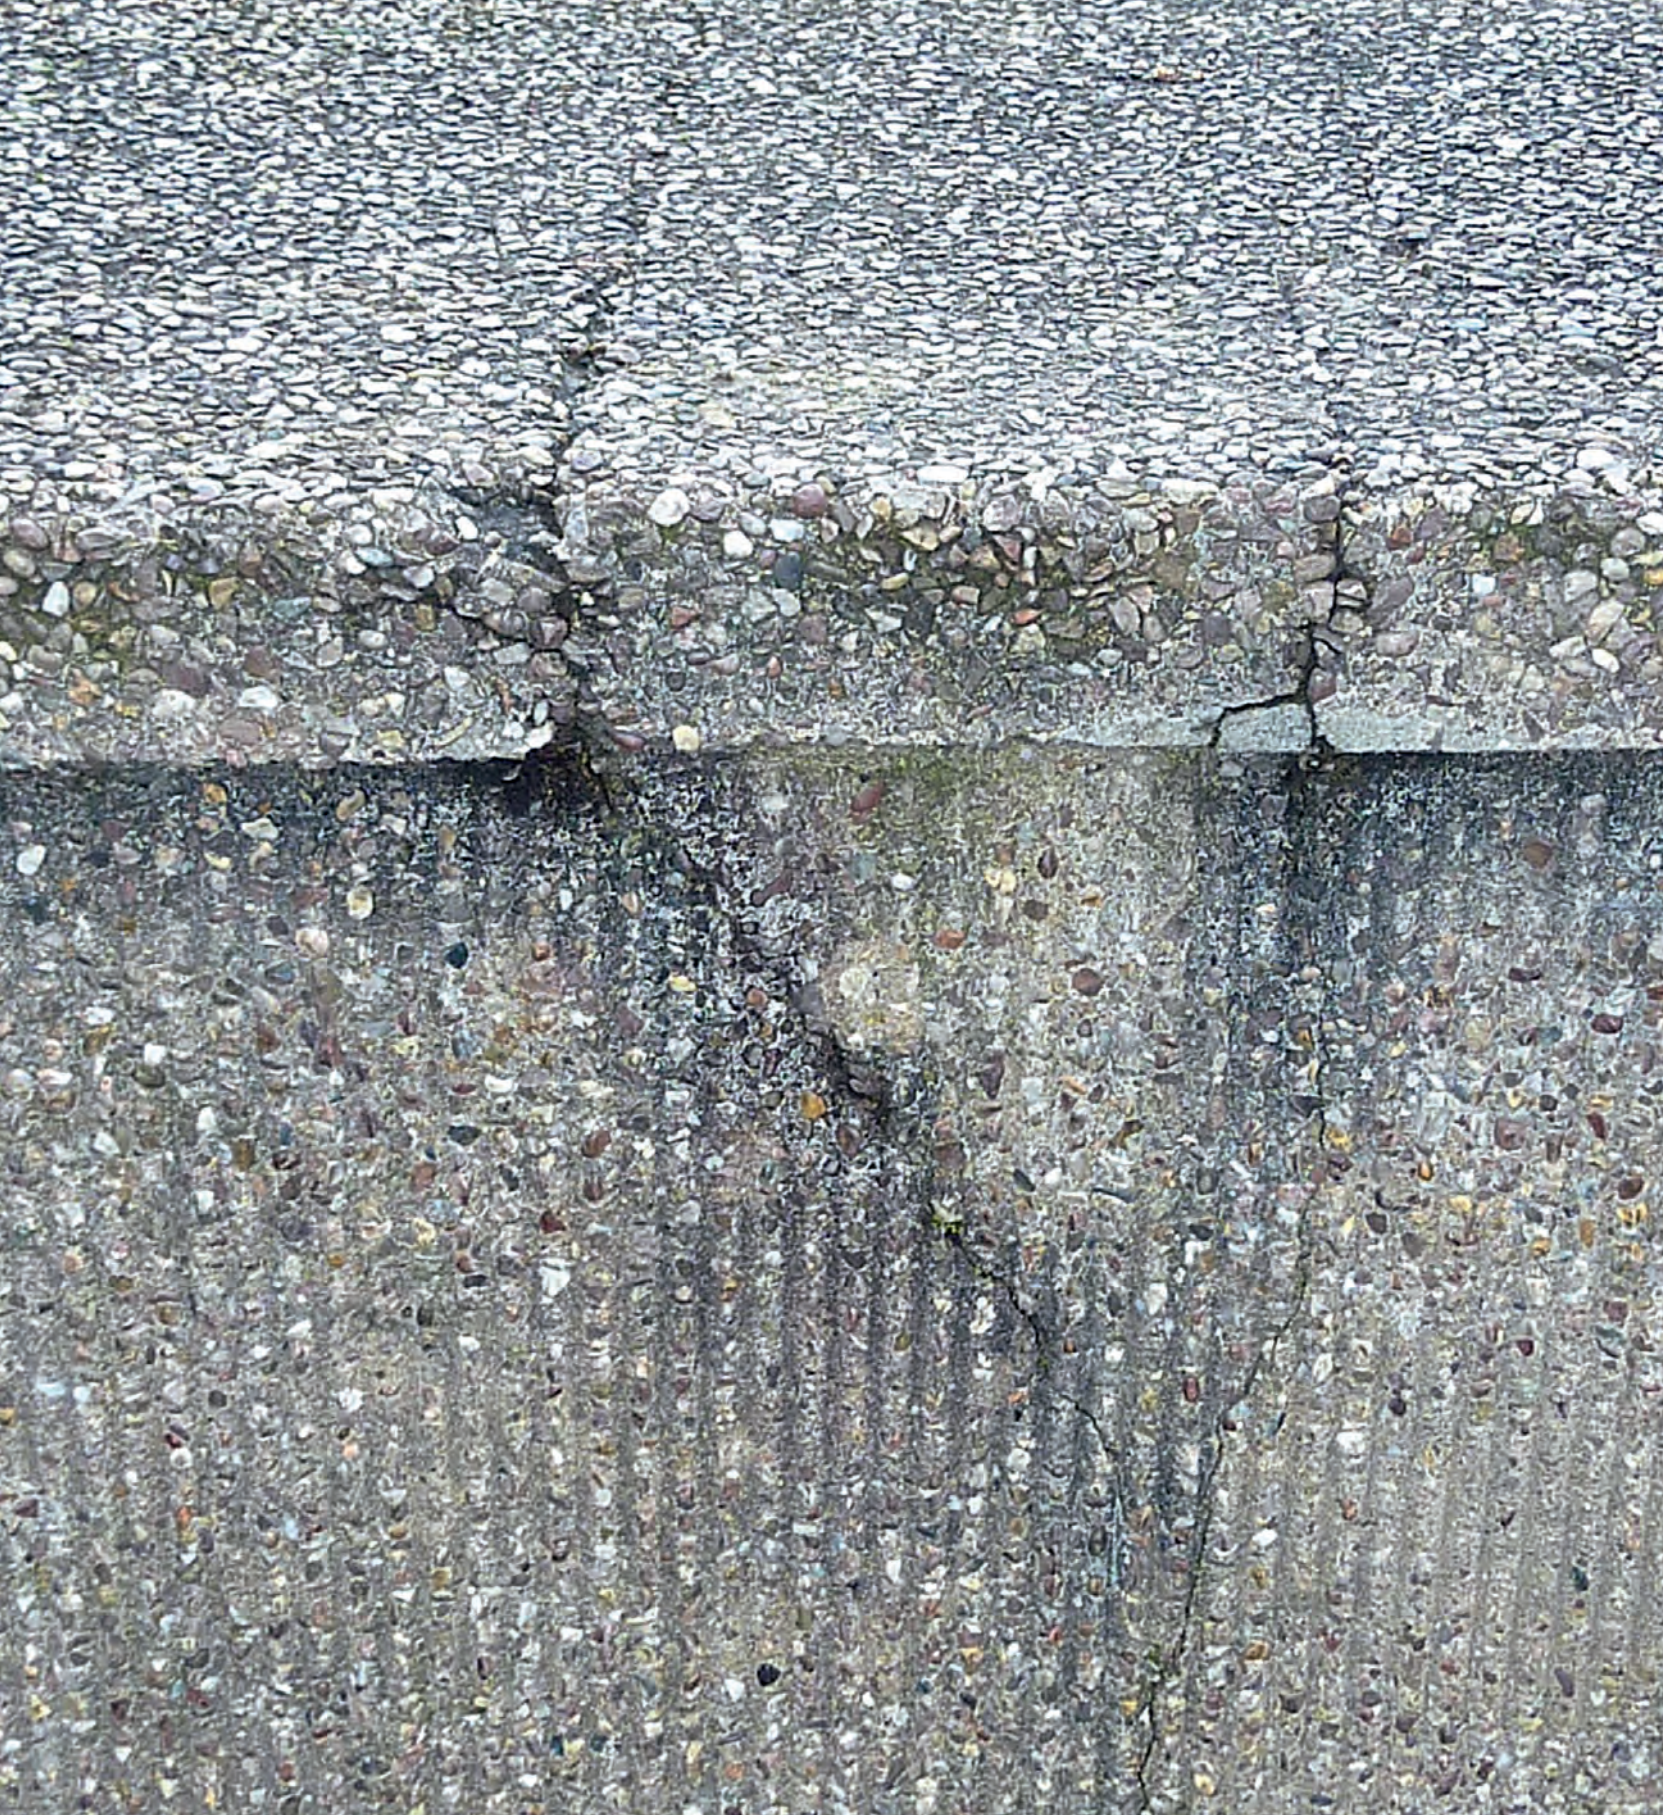
*Facing page:* The cracks on this wall at Dudley Zoo are likely to be due to a combination of plastic settlement cracks and the lack of movement joints.

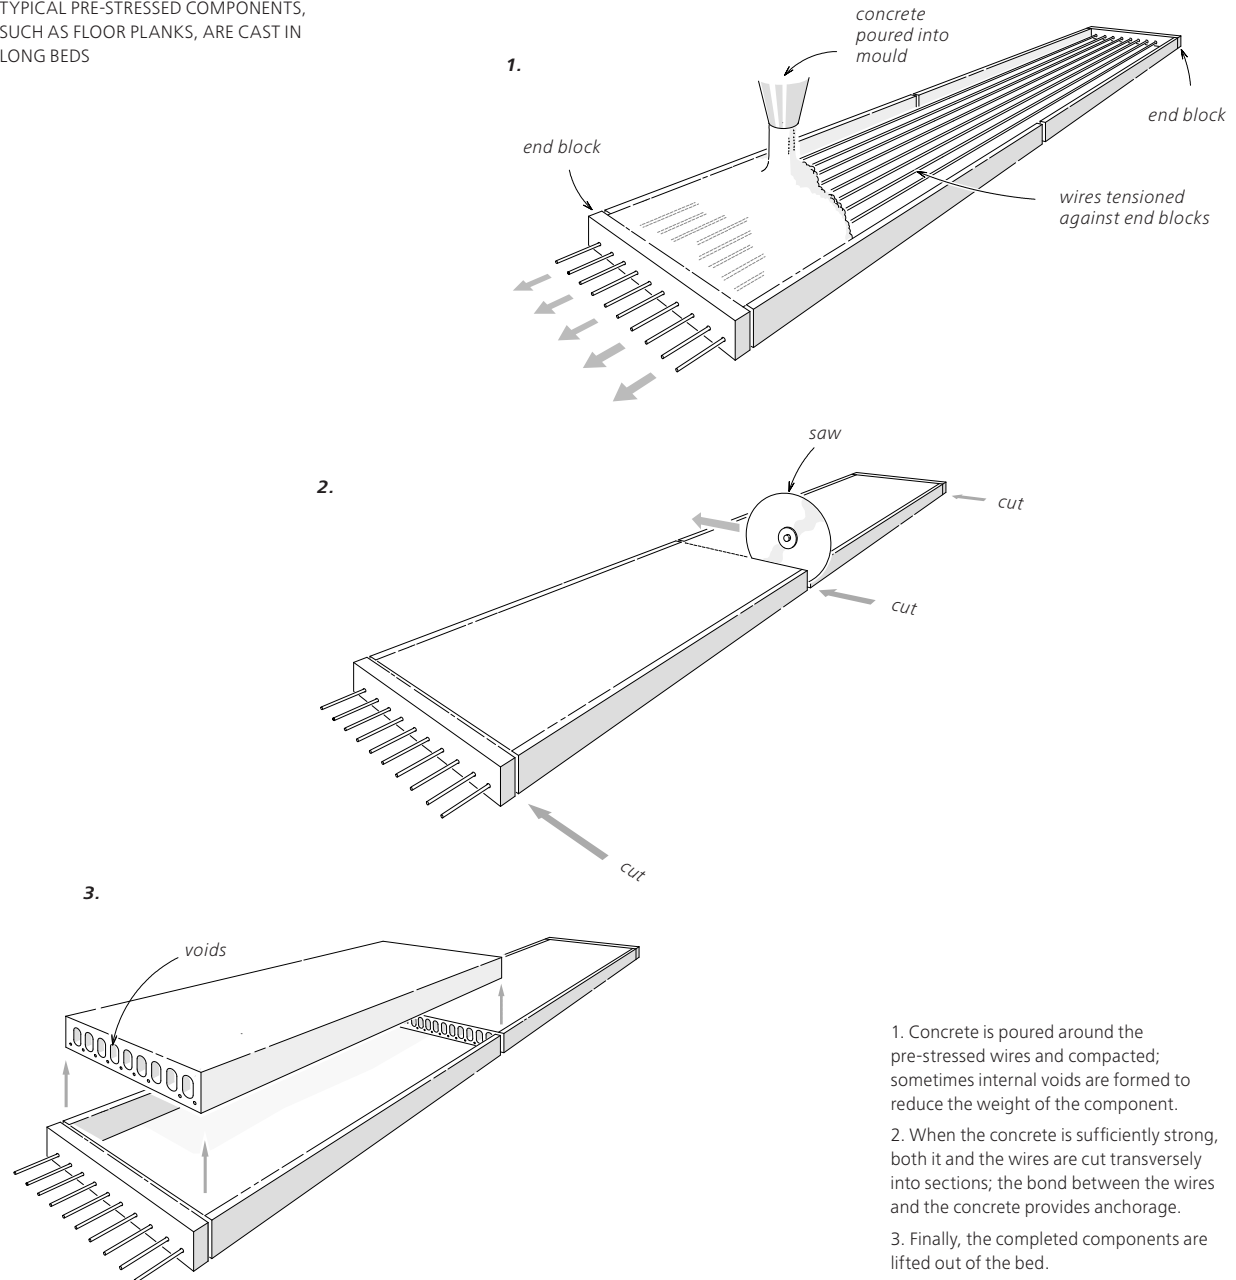
## PRE-TENSIONED PRE-STRESSED CONCRETE

TYPICAL PRE-STRESSED COMPONENTS, SUCH AS FLOOR PLANKS, ARE CAST IN LONG BEDS

1. Concrete is poured around the pre-stressed wires and compacted; sometimes internal voids are formed to reduce the weight of the component.
2. When the concrete is sufficiently strong, both it and the wires are cut transversely into sections; the bond between the wires and the concrete provides anchorage.
3. Finally, the completed components are lifted out of the bed.

Pre-tensioned pre-stressing is the most common method. Steel rods or wires are stretched through a line of moulds, and anchored at each end. The concrete is then placed in the moulds and cured. When the concrete has achieved sufficient strength, the strands or wires are released from their anchorages; as they elastically relax, a load is imposed on the concrete, and this produces the required compressive stress. The strands remain fixed in the concrete by the bond strength that has developed at the steel-to-concrete interface.

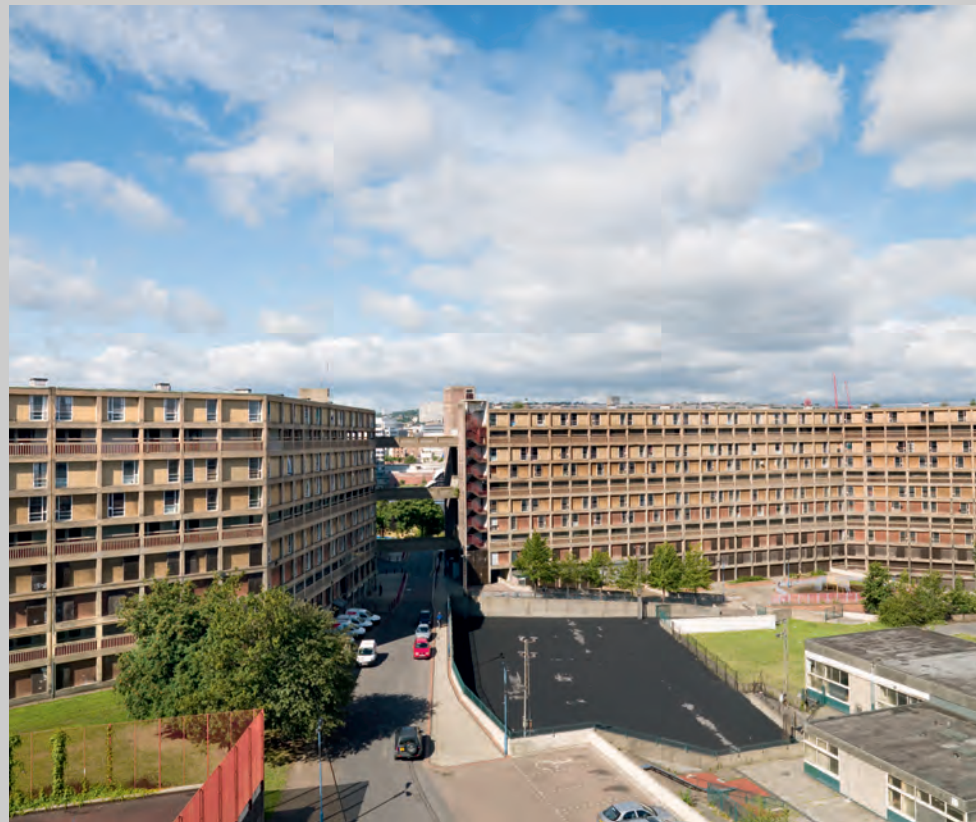
*Facing page:* Park Hill in the 1960s. The concept of the flats was described as 'streets in the sky'. Broad decks, wide enough for milk floats, had large numbers of front doors opening onto them. Each deck of the structure, except the top one, has direct access to ground level at some point on the sloping site. The site also allows the roofline to remain level despite the building varying between four and 13 storeys in height.

Park Hill was originally constructed of an exposed concrete frame with contrasting yellow, orange and red brick infill panelling. Although remaining structurally sound, over time the fabric of the building has decayed and social disadvantages of the estate meant that tenants were hard to find. Recent repair has conserved the concrete frame, but replaced the brick with glass and aluminium panels.
